## **HOME INSPECTION REPORT**

**CLIENT - MR. JOHN DOE**

**ADDRESS - 2233 BRANCH DRIVE, VALDOSTA, GA**

**DATE - 8-26-2015**

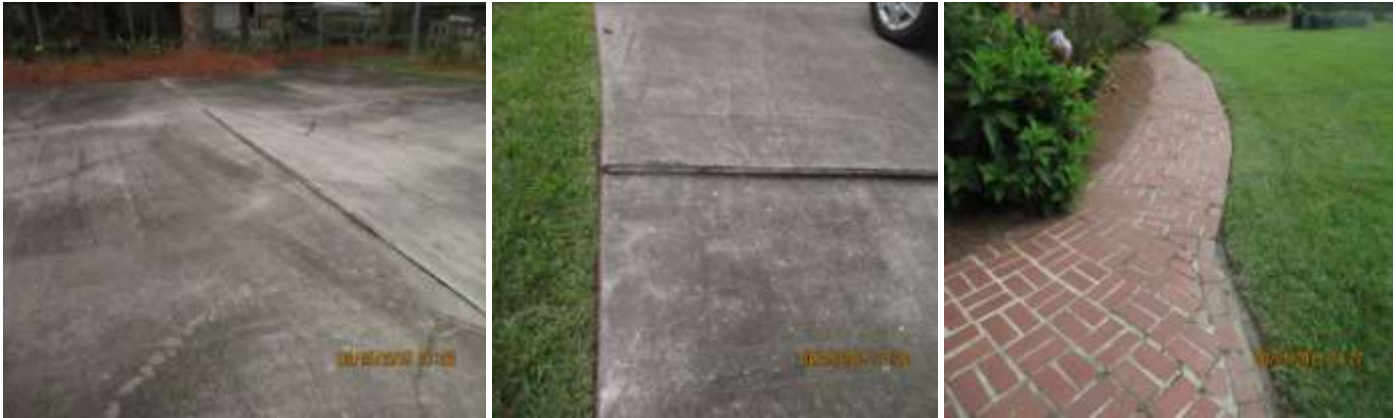
1. The driveway has tree root up lift that has created some 1.5 to 2.5 inch offsets. The brick walkway also has offsets that can be trip/fall hazards.

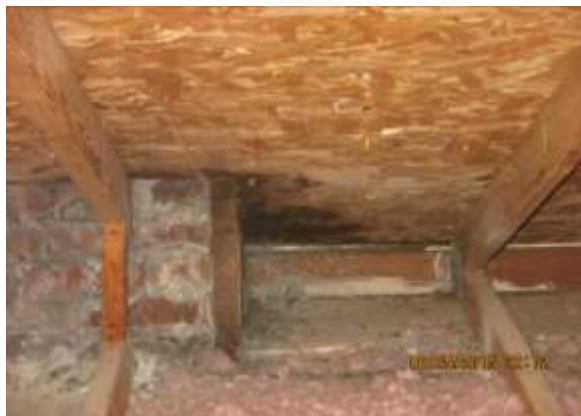
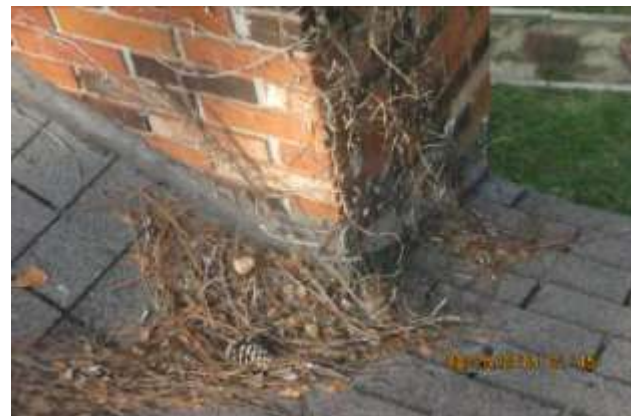
2. There is a leak stain on one side of the chimney in the attic. It appears to be an old leak but I could not get close enough to it to check for moisture to be certain. The flashing and sealant around the chimney looks acceptable so my recommendation is to monitor the area after a heavy rain to be sure.

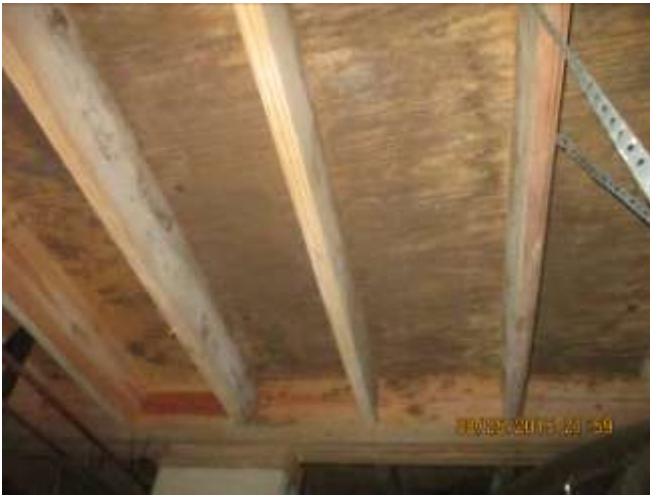
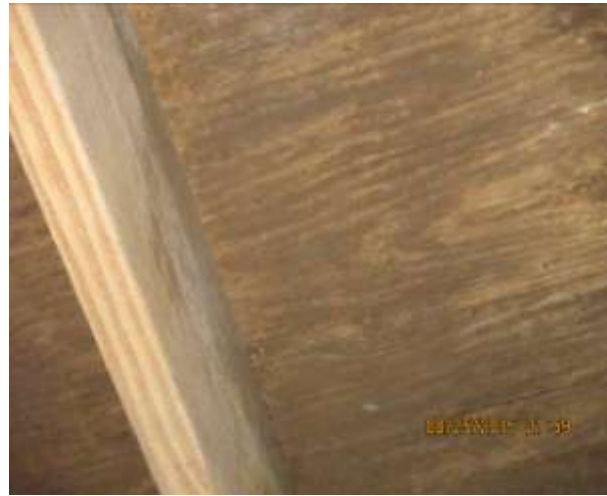
4. The hall bathroom electrical outlet has reverse polarity wiring and is therefore not GFI protected.
5. There are three recessed lights across the aisle in front of the kitchen that would not operate.
6. The front of the home has no crawl space vents from the front door southward. The south end has none because of the garage. This has created a dead air space that has allowed a fairly small area [15x20 feet approximately] of mold like substance growth on the south end of the crawl space subfloor. A moisture barrier, dehumidifier[s] and/or forced air ventilation are three methods that I have seen utilized to help with this issue in my experience however a company that specializes in mold remediation should be consulted if the presence of this substance is of concern.

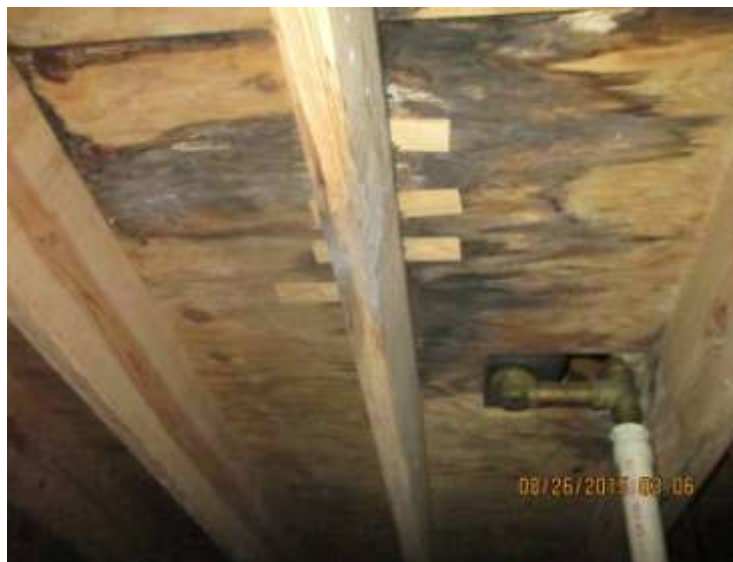
7. There is an area of subfloor under the master tub that has had previous water damage. It has had shims installed between the subfloor and joist most likely to stabilize the floor in that area. The flooring seems sound and the staining appears to have been from the past however I don't know how long it has been since there has been water usage. Although I believe it to be a past issue, I do recommend inspection of the area after water usage has resumed.

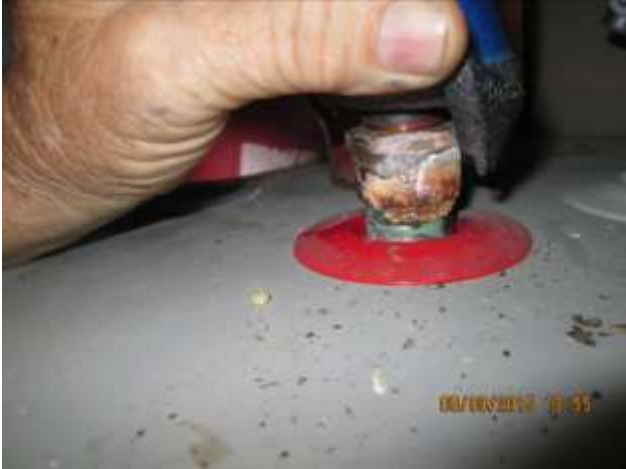
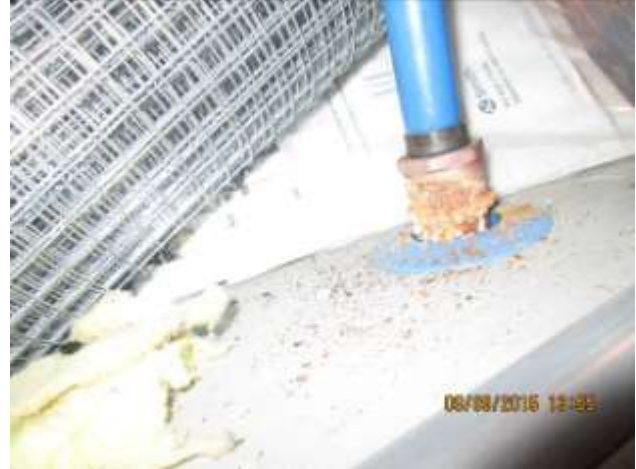
9. The hot water heater hot and cold water connections have galvanic corrosion which will lead to leakage going forward. Proper replacement is recommended.

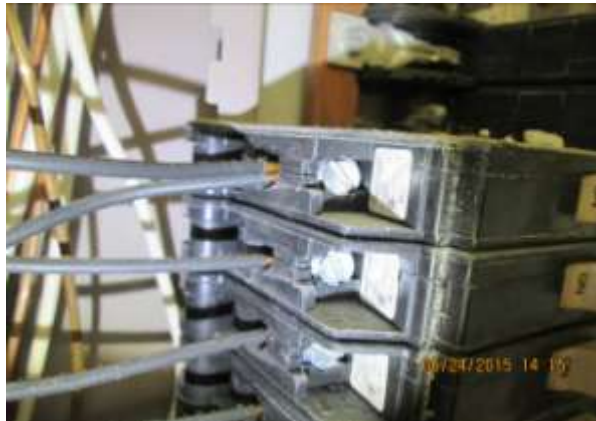
10. A 20 amp breaker in the electrical panel that was designed for one conductor has been double tapped with two conductors. This creates a potential fire hazard and should be corrected by a licensed electrician.

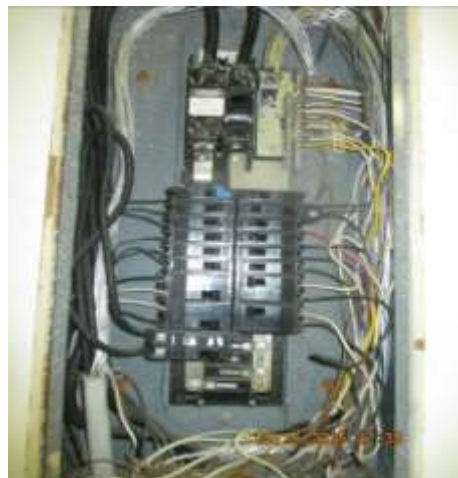
1. **ELECTRICAL-** The electrical service panel is 200 amp. The 110 volt branch conductors are copper. The ground fault outlets tested to be functional with one exception discussed above. There were an adequate number of outlets that were randomly tested and found to be in serviceable condition. The over head lighting operated properly as well as the ceiling fans and bathroom exhaust fans where applicable. The exterior security lights operated properly.

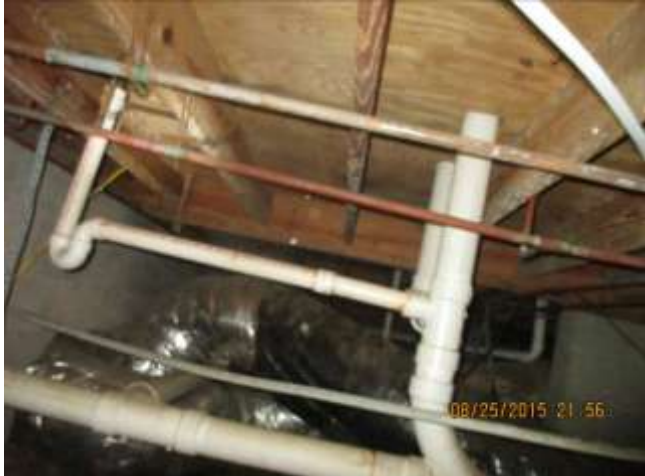
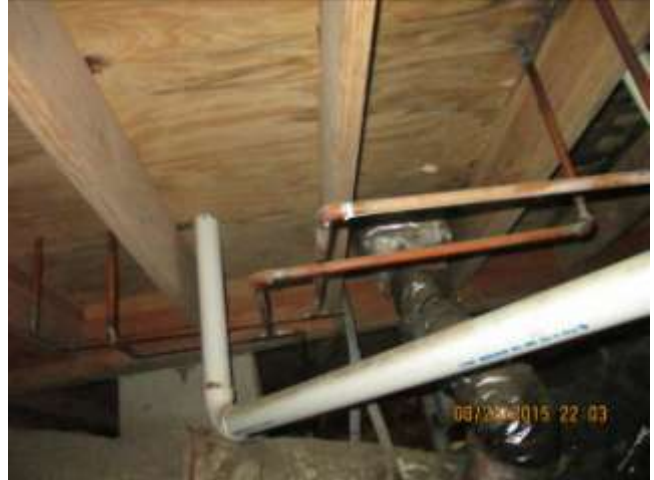
2. **PLUMBING-** The plumbing supply piping is copper pipe and the visible drain lines are PVC. The electric hot water heater is a 40 gallon capacity unit built in 1984. The hot water temperature measured 116 degrees. Flow, pressure and drainage seemed satisfactory and there were no leaks observed. The whirlpool tub functioned normally. Exterior hose bibs were located. The well and septic systems were not inspected. The homes water cut off valve is located at the well.

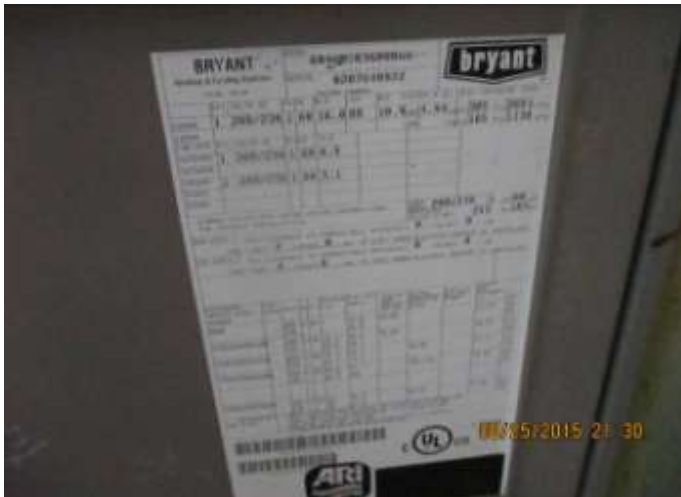
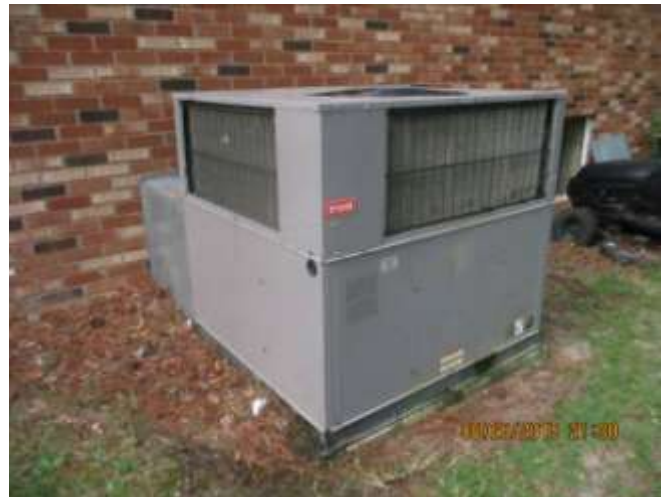
3. **HVAC-** The heating and cooling of the home is accomplished by a Bryant 3 ton combination system heat pump built in 2007. The thermostat is in a lock box so I tested the system as it cycled on and off to control the temperature set point. Its operation was within normal temperature parameters. The visible sections of ducting were adequately insulated, sealed and properly suspended.

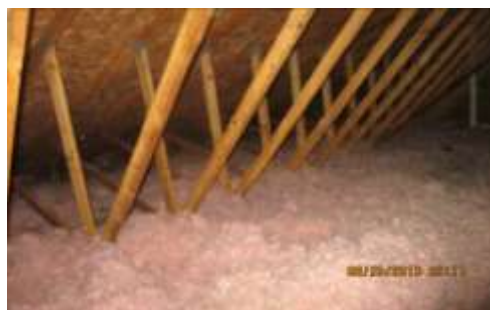
4. **INSULATION/VENTILATION-** The attic insulation is blown in fiber glass. There is approximately 8-10 inches of thickness which should provide an R-30 energy rating. The insulated windows were randomly operated and found to be in acceptable condition as well as the exterior doors. The attic is vented by soffit vents, roof vents and gable vents which should be adequate. There were areas in the attic that were not safely accessible due to insulation covering the floor and no walk ways.

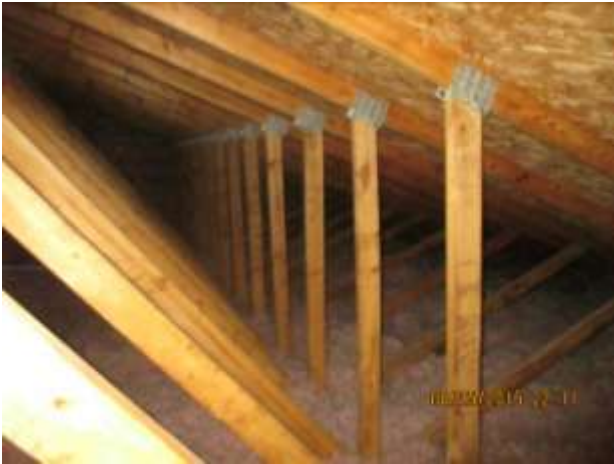
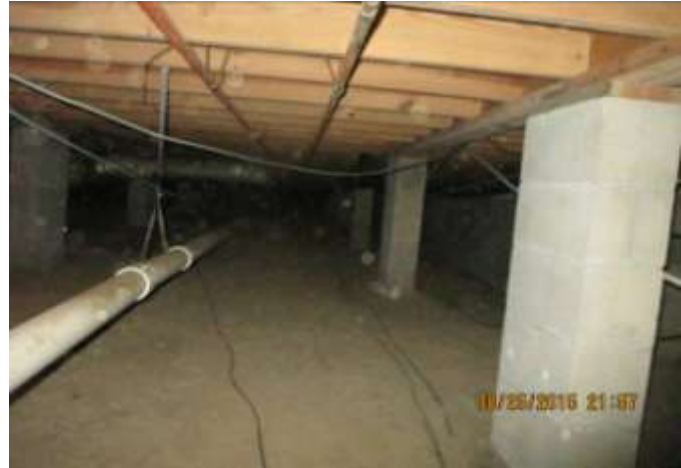
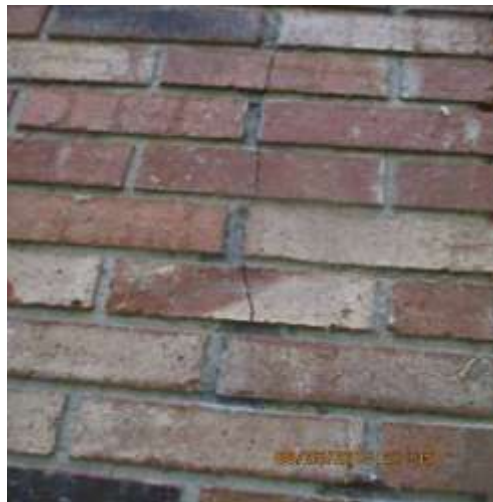
5. **STRUCTURAL-** The brick veneer siding is in serviceable condition and adequately sealed around the wall penetrations. No weep holes were observed. A two foot crack was observed in the chimney about head high. It is not an issue of concern in my opinion. Neither flashings around windows and doors nor the wall structure or drainage system behind the siding was visible for inspection. The observable foundation and roof structure displayed no indication[s] of defective workmanship or condition.

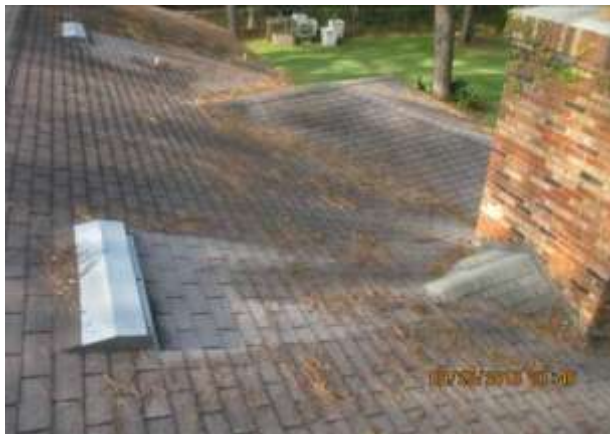
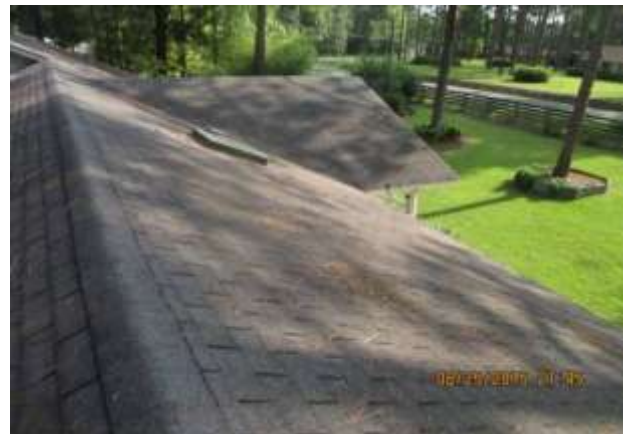
6. **ROOF COVER-** The fiber glass composite roof covering is approximately 15-17 years old in my estimation. The visible and accessible areas were in serviceable condition. The uncovered flashings, plumbing vents and other penetrations were in serviceable condition. No visible evidence of current leakage was observed in the attic or on the ceilings below on the day of the inspection.
